PLATE BONDED STRENGTHENED R.C. BEAMS WITH END AND INTERMEDIATE ANCHORS

M. Z. Jumaat and M. A. Alam
Dept. of Civil Engineering, University of Malaya, Kuala Lumpur, Malaysia.
Email: zamin@um.edu.my

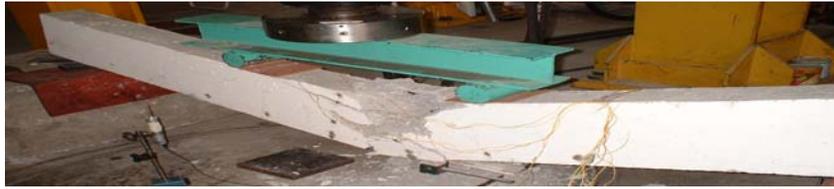
Plate 1. Failure mode of beam A1 (Control beam)

Plates 1, 2 and 3 show the failure modes for test beams of A1, B4 and C4 respectively. It was found from the test that beams A1 and B4 failed in flexure with a ductile failure mode whereas beam C4 failed with a concrete compression failure characteristic. It can be seen that all beams failed with a ductile mode of failure. Beam A1 failed in the natural manner expected of an under-reinforced concrete beam i.e. crack widening crushing of concrete. Beams B4 and C4 failed by concrete in the compression zone crushing but due to strengthening plate the concrete in the tensile zone remained intact.
